# Experiences in boat-building in tsunami-affected countries

**Ari Gudmundsson**, *Fishery Industry Officer (Vessels), FAO, Rome*  
**Daniel Davy**, *FAO Consultant, Naval Architect*

*The FAO has since 2005 been assisting in the reconstruction and rehabilitation of fishing communities affected by the December 2004 tsunami. This article describes experiences and lessons from boat building activities in three affected countries – Indonesia, Sri Lanka and Maldives.*

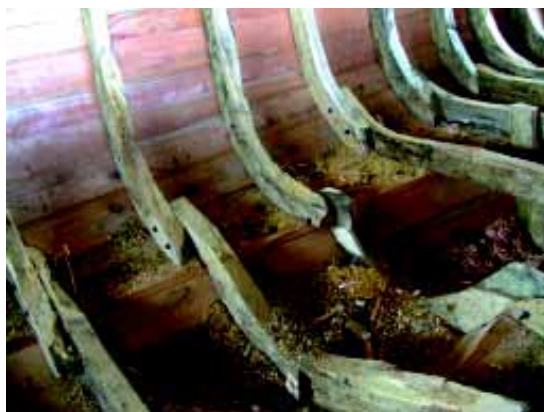
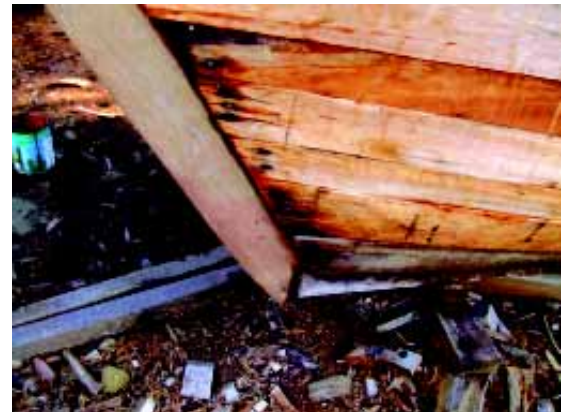
Many of the failings in boat quality have been of the most basic type such as:

- Poorly selected timber, including sapwood and split wood.
- Thin planking, large frame spacing and small keel timbers.
- Sub-standard frame joints with unsuitable arrangement of fastenings.

- Fastenings causing numerous splits in planks.
- Inadequate through-hull fittings and pipe work.
- Use of plain steel fastenings.

*Examples of defective construction in post-tsunami boats from Aceh province, Indonesia.*

advised that unsafe boats should not be handed over to beneficiaries and should instead be modified or broken up.

As the building of boats proceeded it became obvious that remedial activities would be needed to improve boat quality, such as:

- Training of boatbuilders and boat inspectors.
- Development of good-practice guidelines.
- Development of draft regulations for minimum construction standards.
- Work with NGOs and others to raise awareness of quality and provide technical assistance.
