# Experiences in boat-building in tsunami-affected countries

**Ari Gudmundsson**, *Fishery Industry Officer (Vessels), FAO, Rome*  
**Daniel Davy**, *FAO Consultant, Naval Architect*

*The FAO has since 2005 been assisting in the reconstruction and rehabilitation of fishing communities affected by the December 2004 tsunami. This article describes experiences and lessons from boat building activities in three affected countries – Indonesia, Sri Lanka and Maldives.*

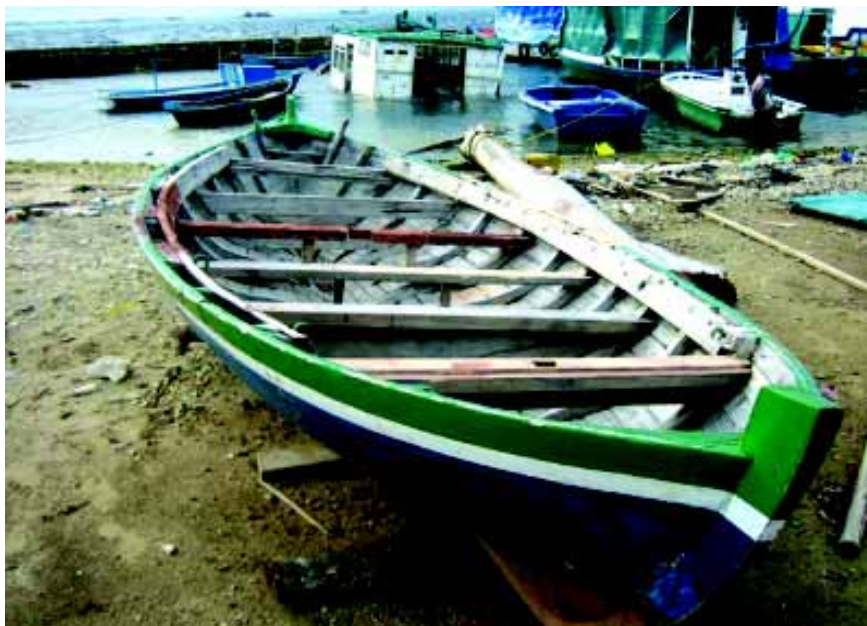
*The Masdhoni of the Maldives. Some 50 Masdhonis, 85 ft long, are being built. Even 107 ft Masdhonis are under construction.*

reference to any guidelines or scantling rules for this size of vessel is a cause for concern.
